Engineering geology and future stability of the El Risco landslide, NW-Gran Canaria, Spain

Abstract A 200 m long segment of the only main road in NW-Gran Canaria is built on landslide deposits near the village of El Risco. Structural mapping and analysis of the topography reveal that the N–S striking landslide head scarp is the upper part of a sub-circular failure surface. The southern side of the landslide is delimited by a much older E–W strike-slip fault. Prior to pavement resurfacing in 2006, cracks in the road tarmac at the northern and southern sides of the landslide suggested ongoing creep movement. Slope stability analyses suggest that peak ground acceleration (PGA) was the most likely trigger for the initial failure.

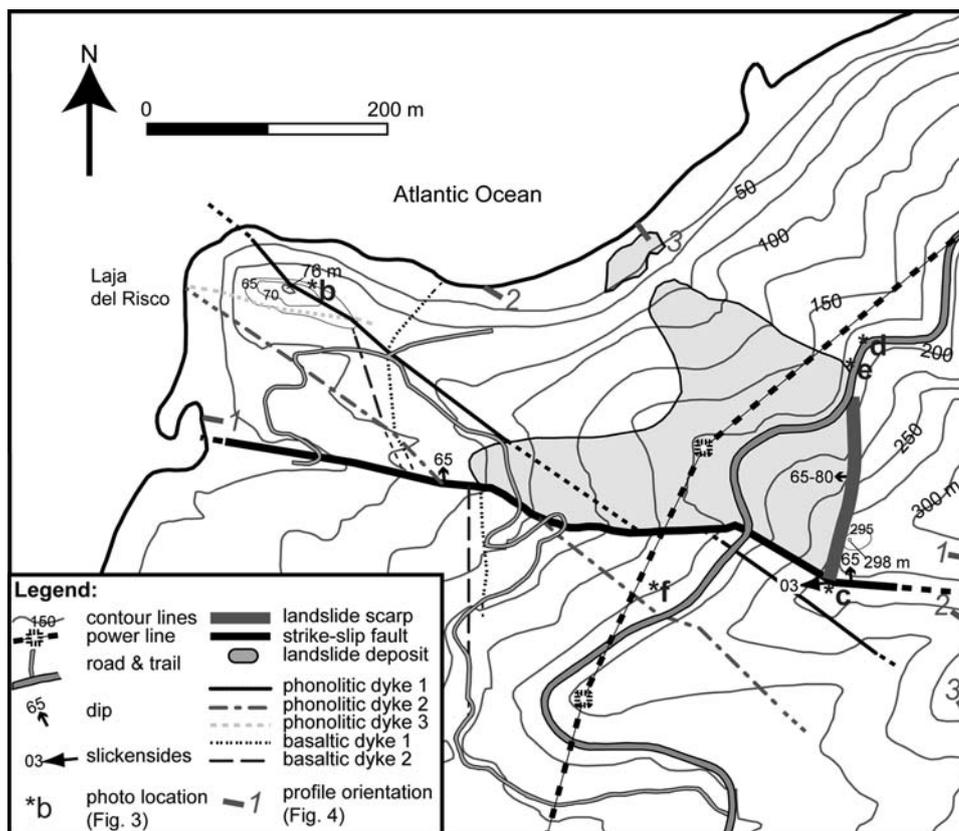
A horizontal offset of ~ 55 m is observed for three dykes (P2, B1, B2, see Fig. 2) whilst no offset of P1 is obvious although a 200 m long segment of this dyke is missing and probably was removed or covered by the landslide. The observed displacement is due to an E-W strike-slip (sinistral) fault located at the southern boundary of the study site and characterised by a well-developed and solidified fault breccia. The attitude of the fault plane, exposed in three main areas, is $085/65$ N. In one site below the road, a fault plane section (2 m high, ~ 30 m long) contains intense calcite and zeolite mineralisation. Slicensides found in two locations (Fig. 2) plunge $2-4^\circ$ to 264° ($S84^\circ W$), indicating strike-slip movement. The fault extends beyond the landslide area inland for at least 200 m, with small vertical displacements estimated to be up to 15–20 m down-dip to the north. These observations suggest that this fault is older than the landslide and probably related to Miocene cyclic activity of the Tejeda magmatic system (cf. Troll et al. 2002).

Fig. 2 Topographic map of the El Risco landslide and surroundings. Locations of photographs (Fig. 3) and topographic profiles (Fig. 4) are indicated

east by a 65° – 80° head scarp with a weakly arcuate N–S trend (Figs. 2, 3, 4). The head scarp is considered to represent the exposed prolongation of a sub-circular failure surface underlying the displaced rock mass. The surface of the head scarp is irregular and rough and neither fault breccia nor slickensides were observed. No trace of the failure surface is exposed below the road to the north. To the south, however, the head scarp terminates at right angles to the older strike-slip fault (Fig. 2). Whilst the older strike-slip fault did not act as a primary failure surface, it appears to have provided a constraint to the southern extent of the landslide.

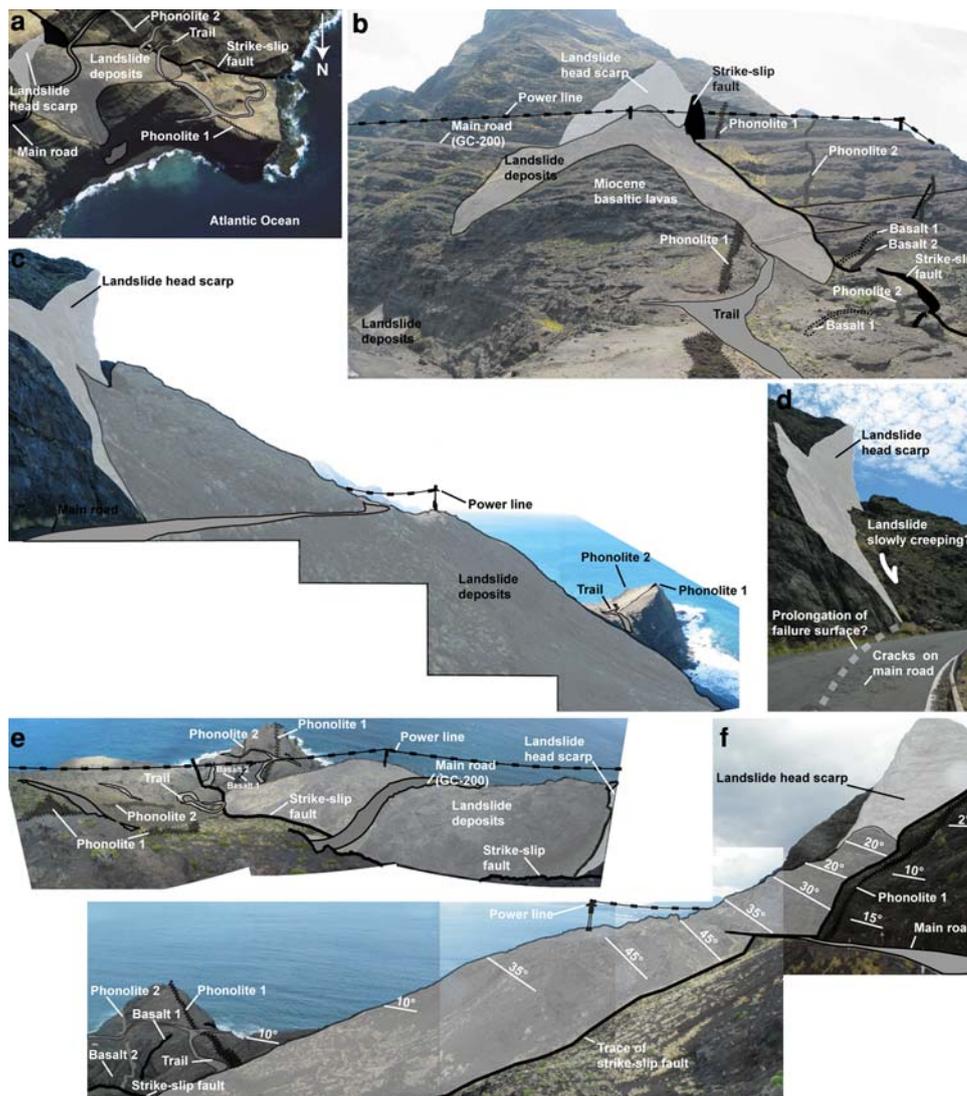
Fig. 3 Images of the El Risco landslide with the affected infrastructure and the major geological features labelled.

The upper part of the failed mass is composed of detached blocks that kept their relative stratigraphic position but were rotated backwards (Fig. 3f). In contrast to the regional basaltic lavas dipping $<15^{\circ}$ E, the displaced flows have dips of 20° E– 25° E towards the landslide head which steepen to 45° E in the middle part, just below the road, before shallowing to 10° E towards the toe. Following Varnes (1978), the El Risco landslide would be described as a rotational slump. However, the two lobes of landslide deposits forming the landslide toe consist of disaggregated blocks which were probably emplaced at higher velocities as a small-scale debris avalanche.

During the spring 2005 fieldwork, cracks in the road tarmac were observed along the northern and southern edges of the slide (Fig. 3d), suggesting ongoing creep. The GC-200 road was subsequently resurfaced in 2006.

a Satellite image of the El Risco landslide, courtesy of GRAFCAN. **b** Panorama of the landslide as seen from the west, and **c** from the north. **d** Photo (taken in April 2005) of cracks in road GC-200 coincident with the northern landslide edge. **e** View from the east. **f** Photo mosaic taken from the south showing rotation of landslide blocks

It is recommended that monitoring is undertaken, including regular observation as well as the installation of monitoring instruments (inclinometers and piezometers) to determine the precise displacement rates and hydrological conditions in the area. In addition, in view of the hazards presented by re-activation of the El Risco landslide, the costs of periodical road stabilisation should be estimated and compared to that of the construction of a new road section bypassing it.

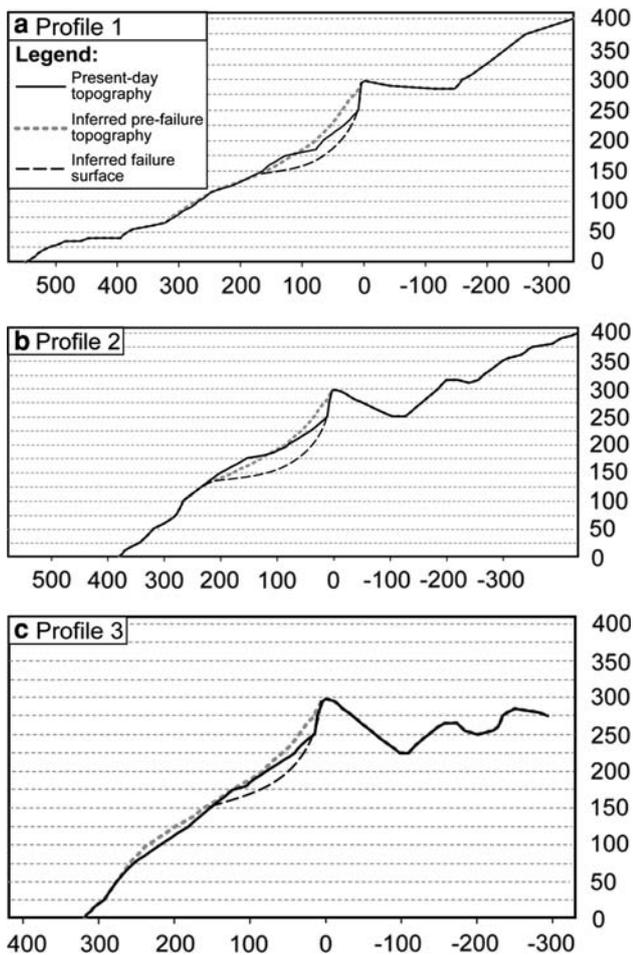
topographic profiles suggest that the lower part of the sub-circular failure surface is located slightly above 125–135 m asl (Fig. 4b). Pre-failure topography was inferred by comparing topographic patterns encountered inside and outside the landslide area. This suggests that a significant volume of deposits from the northern arm of the slide may have been transported to the beach where it was probably rapidly eroded by wave action (Fig. 4c). From the assumed pre-failure topography, the inferred position of the failure surface and the landslide area, a volume of around one million cubic metres may have been displaced.

Fig. 4 Current topography, inferred pre-failure topography and inferred failure surface geometry for **a** profile 1, **b** profile 2 and **c** profile 3 of Fig. 2

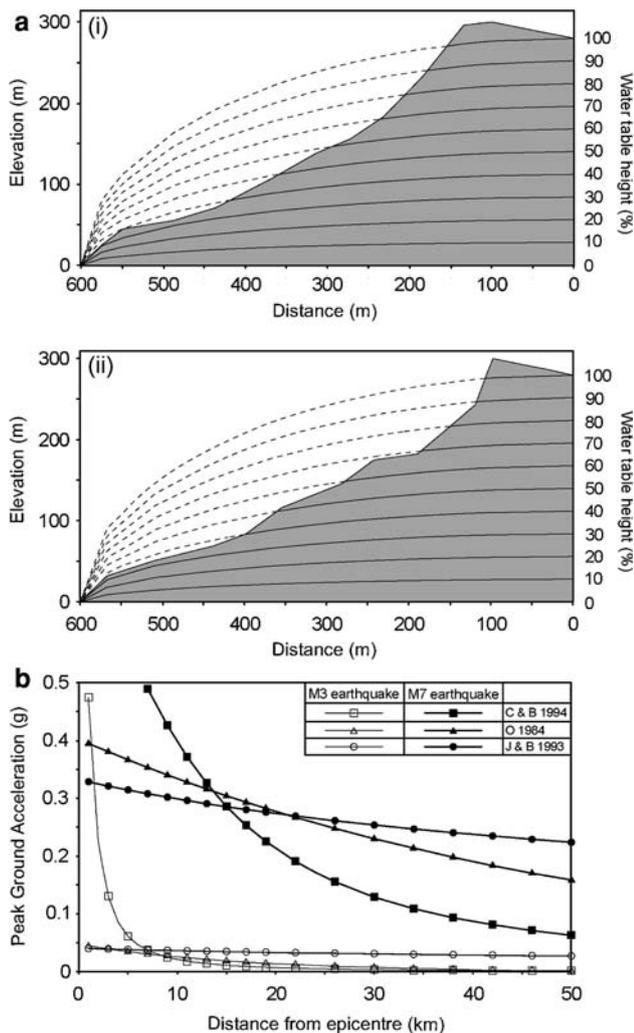
their top and bottom breccias apparently forming horizons of increased permeability (Cabrera and Custodio 2004). In the absence of clay-rich units, perched water tables are unlikely to develop in the area. The proximity of the slope to the sea, the elevation of the failure surface above sea level and the existence of lower land behind the scarp indicate generally dry conditions are likely to have pertained on the upper sector of the slope, where the failure developed. Nevertheless, different ground water table elevations were considered, from 0 to 100% in 10% increments. Following Dupuit–Forchheimer theory (Bear 1972), the water table model was simplified to an ellipse with the major and minor axis lengths equal to the modelled slope width and maximum water table height (Fig. 5a).

Ground accelerations resulting from seismic events are a very common trigger for rock slope instabilities (Keefer 2002). Most significant to the present study is seismic activity related to an off-shore strike-slip fault oriented NNE-SSW and located between the islands of Gran Canaria and Tenerife, 30 km from the El Risco site. This system has been active historically, with recorded magnitudes of up to 5.2 (Mezcua et al. 1992) whilst palaeoearthquake investigations indicate maximum values of $M = 6.8$ (González de Vallejo et al. 2003). In addition, lower magnitude earthquakes (generally $M < 3$) have been repeatedly reported for all the Canary Islands (Instituto Geográfico Nacional data 1993–2004). From this, two seismic scenarios were modelled: a deep (15–50 km) ~M7 earthquake at a distance of ~30 km and a shallow (<20 km) ~M3 earthquake at a distance of ~10 km. Following a number of empirical solutions which relate peak ground acceleration (PGA) to event magnitude and distance from source (Okamoto 1984; Joyner and Boore 1993; Campbell and Bozorgnia 1994), PGA values of up to 0.35 g were chosen (Fig. 5b). This is consistent with other studies (e.g. Voight et al. 1983; Hürlimann et al. 2000).

Fig. 5 a (i) Pre- and (ii) post-failure water table geometries used in the stability models, following the Dupuit–Forchheimer theory. **b** Peak ground acceleration as a function of earthquake magnitude and distance to the epicentre using the empirical equations of Campbell and Bozorgnia (1994), Joyner and Boore (1993) and Okamoto (1994)

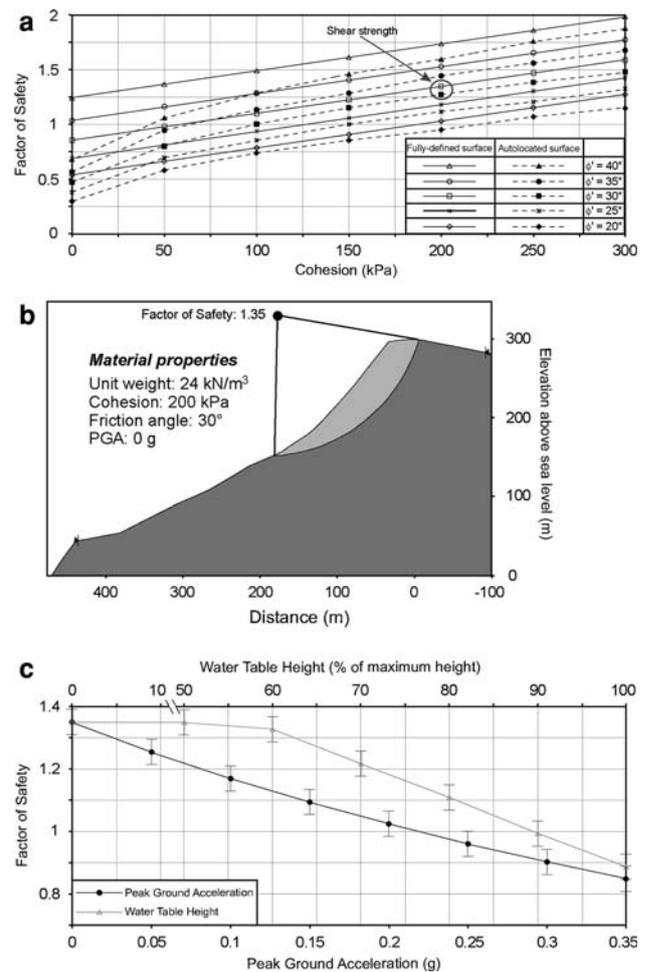
Leelarntnam (2001), show that a cohesion value of ~ 200 kPa and an angle of internal friction of $\sim 30^\circ$ best reproduce the observed/inferred failure surface (Fig. 6b). Using these values under dry conditions, an initial, static factor of safety of 1.349 was obtained.

The modelling indicated that the initial factor of safety is not affected by water table heights of up to 60% of the total maximum height (Fig. 5a, 6b). Water table heights between 60 and 100% of the total maximum height result in a gradually reduced factor of safety, to below 1 for values above $\sim 90\%$.

Peak ground accelerations have a more significant effect on the factor of safety; a PGA value of ~ 0.22 g being sufficient to decrease the factor of safety to a value of 1 (Fig. 6c).

Fig. 6 Results for model (i). **a** Factor of safety as a function of material cohesion for different angles of internal friction, for models with a user-specified failure surface (fully-defined) and models with a non-specified failure surface (autolocated), following the methodology proposed by Wesley and Leelarntnam (2001). **b** Calculated initial failure surface. **c** Comparison of the decrease in the factor of safety induced by peak ground accelerations and increasing water table heights. The error bars represent the variation given by the range of material unit weights used in the calculations

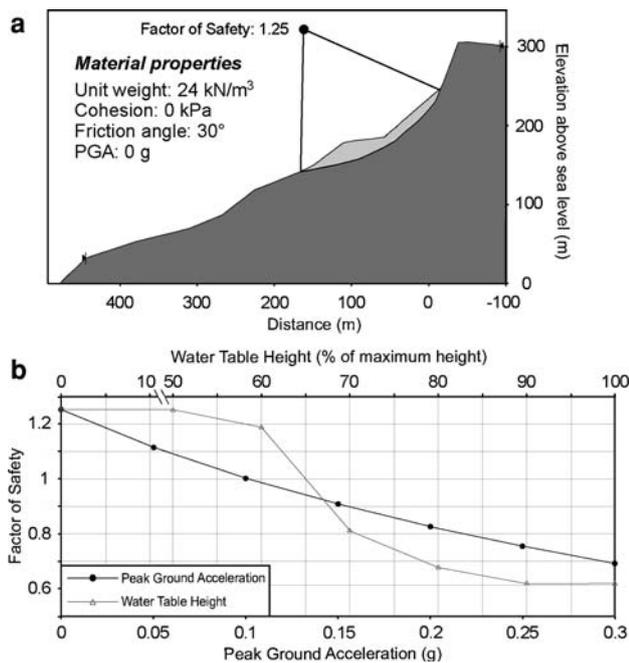
Using the residual cohesion value of 0 kPa and an angle of internal friction of 30° , the model showed a factor of safety of 1.252 for the present-day slope under dry conditions (Fig. 7a). As with model (i), the factor of safety remains constant with water table heights up to 50% of the total maximum height. A sharp decrease in the factor of safety is observed with higher values, with a value of $\sim 65\%$ resulting in a factor of safety of 1 (Fig. 7b). The relationship between the factor of safety and peak ground acceleration established in model (i) also pertains for model (ii), although the factor of safety is reduced to 1 with a peak ground acceleration of ~ 0.1 g (Fig. 7b).

Fig. 7 Results for model (ii). **a** Calculation of failed mass geometry. **b** Comparison of the decrease in the factor of safety induced by peak ground accelerations and increasing water table heights for the present state of the slope

Modelling the current slope stability conditions suggests a factor of safety of 1.252. This is consistent with the ongoing creep of the landslide mass indicated by cracking of the road tarmac at the northern and southern extremities. The calculations show that a water table height of 65% of the total maximum height would create pore pressures high enough to destabilise the slope. With a 10% safety margin, a failure could be triggered if the water table rises to some 165 m above sea level at a location directly beneath the landslide head. This situation is difficult to envisage at the El Risco site, unless the permeability of horizons between individual lava flows has been overestimated.

It was calculated that a seismic event generating a peak ground acceleration of only 0.1 g at the El Risco site would cause further failure of the landslide mass under dry conditions. Applying a 10% safety buffer indicates a threshold PGA value of 0.09 g, equivalent to a $\geq M5$ earthquake along the NNE–SSW sub-marine fault 30 km west of El Risco or a $\geq M4.5$ earthquake located within a 10 km radius. Considering that at least two $\geq M5$ seismic events occurred historically at the sub-marine fault between Gran Canaria and Tenerife and a M3–4 earthquake occurred in the vicinity of the El Risco site as recently as 1999 (Instituto Geográfico Nacional data 1993–2004), both of these scenarios are likely to occur again in the foreseeable future.
